# Technical Data Sheet

Product Name: Torrent Concealed Cistern

## Technical Bulletin - On Site product adjustment guidance.

**Functional problem:** Flush / drop valve not closing.

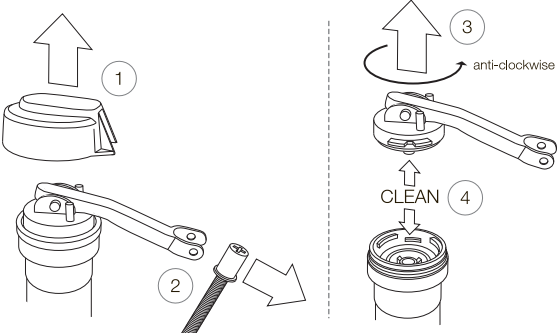
Problem	Potential cause	Suggested action
The Fill Valve does not work or isn't controlling the water supply efficiently.	<p>The flush valve may be blocked.</p>

<p>Follow the instructions below and clean the water inlet orifice and cap. If unsuccessful, replace the fill valve with a new one.</p>

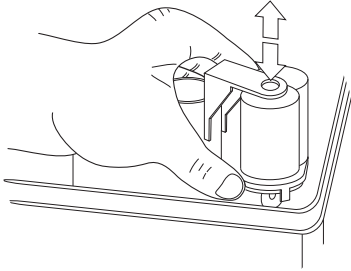
Water leaks from the base.	<p>1 The flush valve stem may be obstructed or jammed, preventing it from falling back into position.</p>

<p>Ensure that there is nothing obstructing the flush valve and the stem can extend up and down.</p>

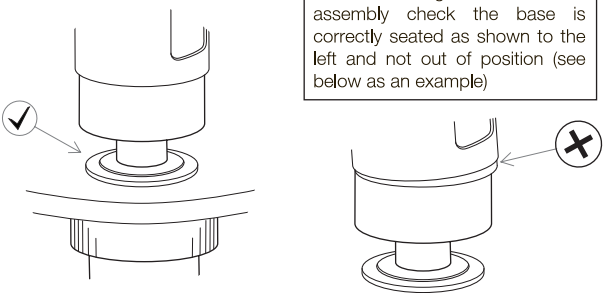
<p>2 The rubber gasket may have fallen off or could be damaged.</p>

<p>Ensure the rubber gasket is fixed in position. However, If it's damaged a replacement is needed.</p> <div> <p>NOTE: Before re-fitting the flush valve assembly check the base is correctly seated as shown to the left and not out of position (see below as an example)</p>

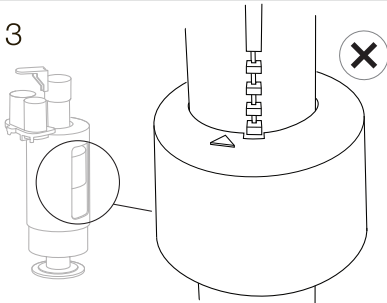
Problem	Potential cause	Suggested action
Water leaks from the base. (Continued)	<p>3</p>

<p>Ensure the rotation of the blue float component is in the correct position.</p> <p>If it isn't (as shown left) the blue float component can catch on the adjustment measure</p>  
The flush valve does not work properly.	<p>The pneumatic tubes may have been installed incorrectly.</p>  	<p>Ensure the following:</p> <p>The blue tube must be connected to the joint marked with a half circle,</p> <p>The transparent tube should be connected with the joint marked with a full circle.</p>  
The pan washer is leaking.	<p>The cistern may have been installed in an incorrect position causing the flush bend to pull out of position.</p>  	<p>Ensure the cistern is in the correct position and ensure the flush bend is fully connected to the pan.</p> <p>Please see the instruction manual provided for fitting instructions.</p>

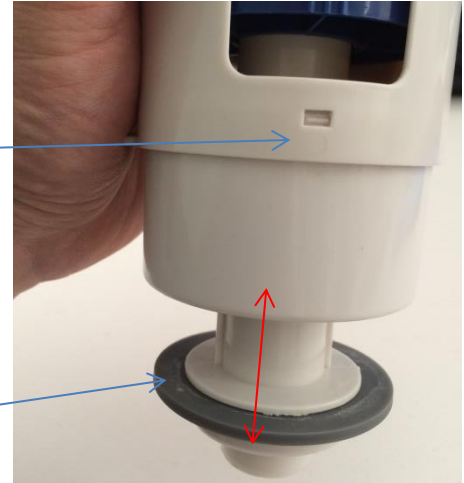
1) Image description of correctly functioning valve :

Snap Hook located in middle of slot

Valve drops up and down freely

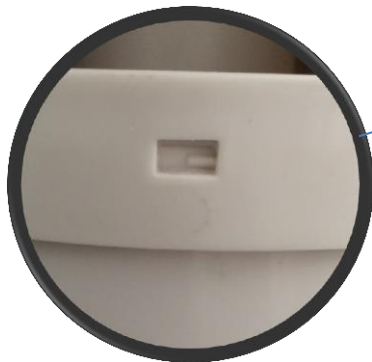
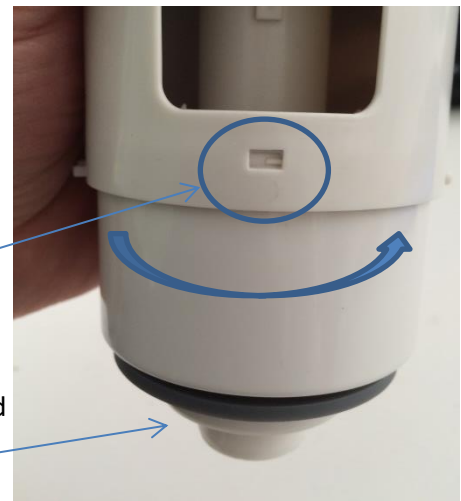
2) If base part of flush valve assembly is slightly twisted, then the snap hook is not engaged in slot. This causes the flush valve to stick and not drop back down with gravity when push button is released.

Valve sticks in place and does not drop with gravity

**THIS MIGHT BE IDENTIFIED AS THE FLUSH CONTINUES WHEN THE BUTTON HAS BEEN RELEASED OR PUSH BUTTON STICKS.**
