# Vitra S20 Troubleshooting

Sticking or not flushing  
Passing water

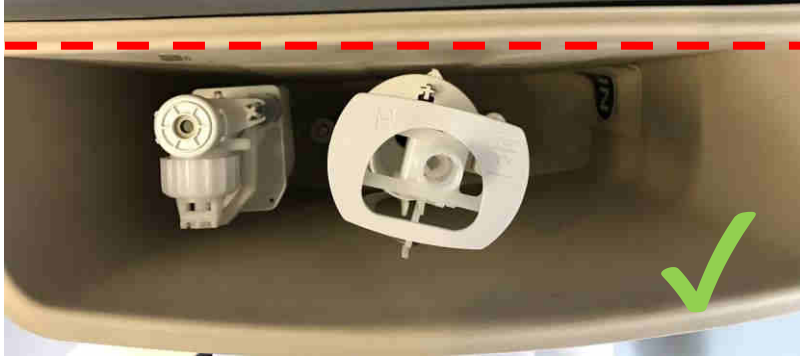
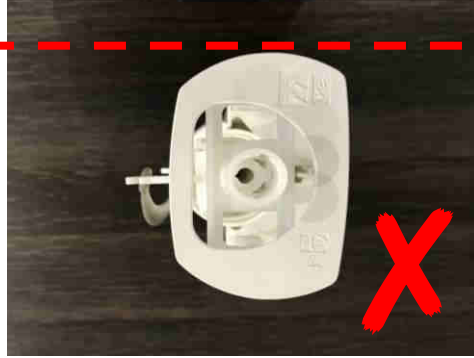
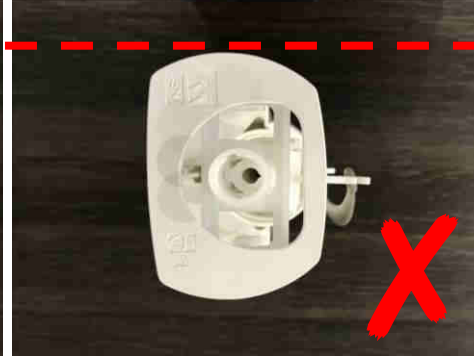
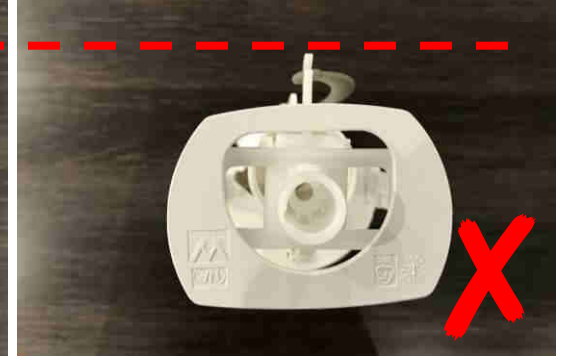
First check that the valve position is as shown above, the valve should be clear of the cistern wall, if not remove the valve and re-position.

If the valve position is correct, check the valve settings are still in the factory set positions detailed in the table (right).

If the problem persists please contact Siamp Aftersales on 0161 681 2120 or [aftersales@siamp.co.uk](mailto:aftersales@siamp.co.uk)

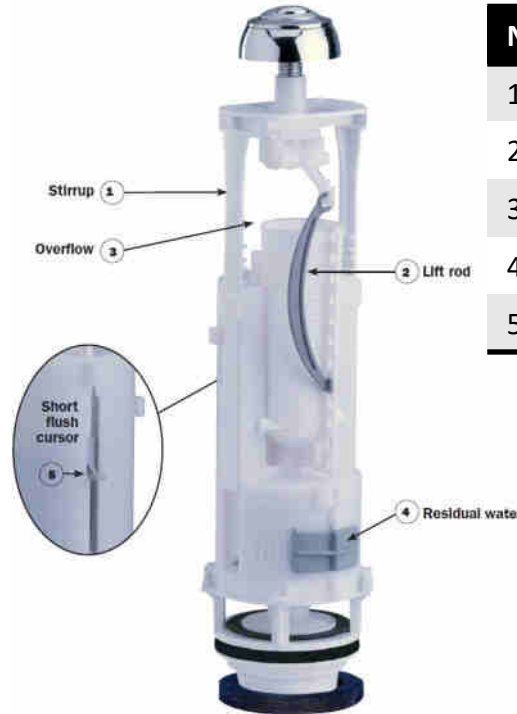
No	Description	Setting	Figure
1	Stirrup	Position 7 (number 6 will be visible)	A
2	Lift Rod	Position 5 (4 holes above will be visible)	B
3	Overflow	Factory set. D will be visible	B
4	Residual Water	0	C
5	Short flush cursor	10	D

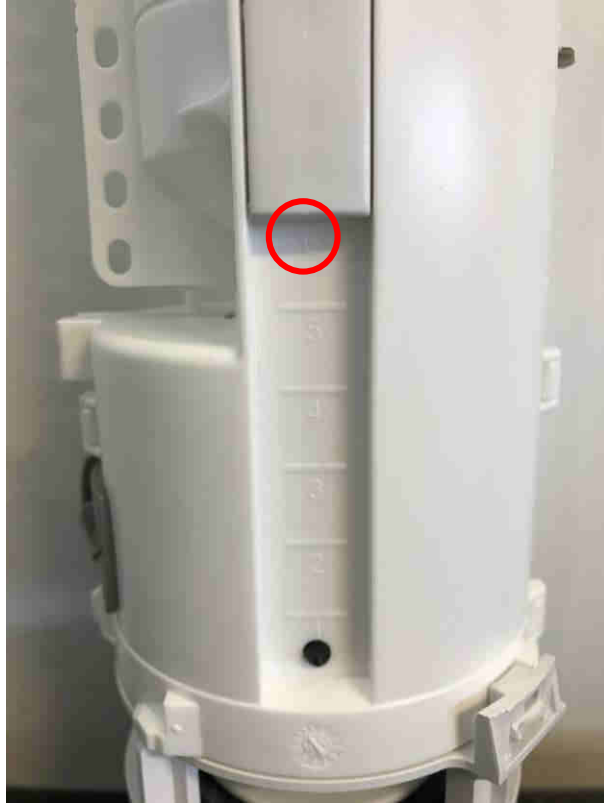
Fig A.  
Stirrup in position 7.  
(number 6 will be visible)

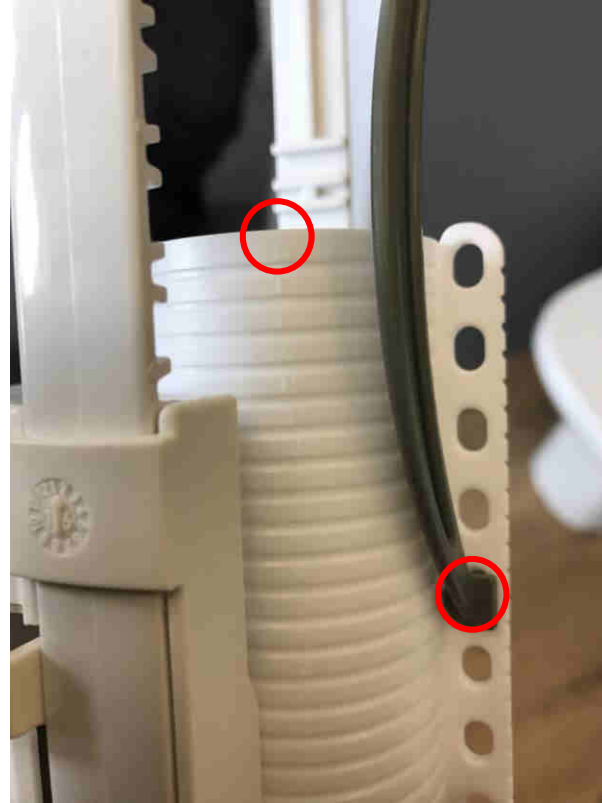
Fig B.  
Lift Rod in position 5  
(4 holes visible above)

Overflow tube pre-cut at D

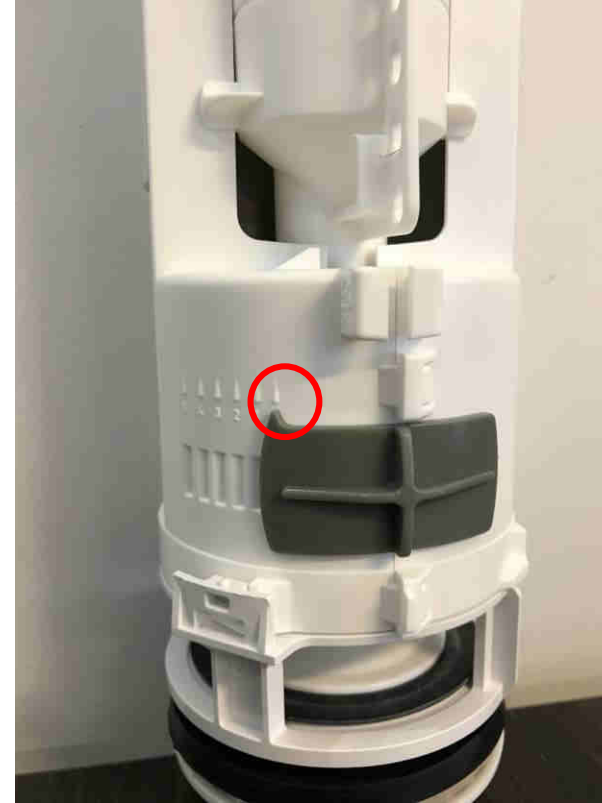
Fig C.  
Residual Water set at 0

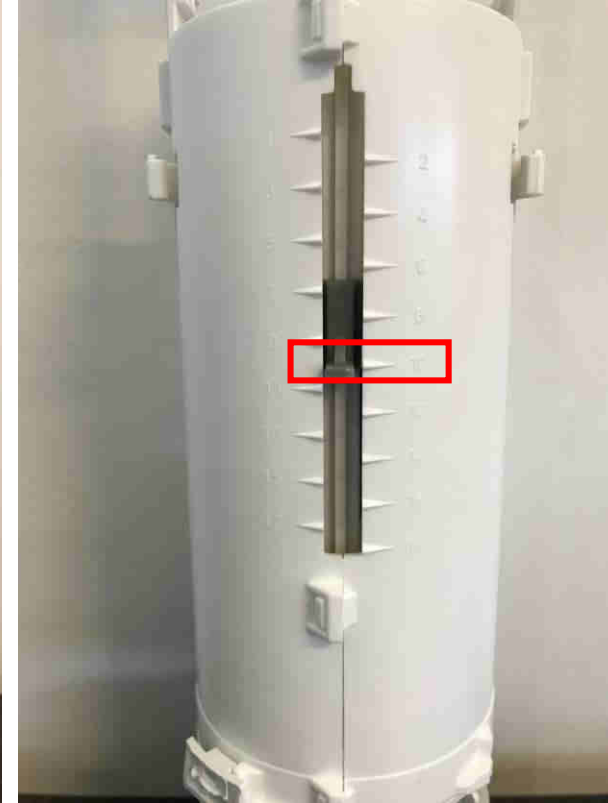
Fig D.  
Short flush cursor set at 10
