# Technical Data Sheet

Product Name: Torrent Concealed Cistern

## Technical Bulletin - On Site product adjustment guidance.

**Functional problem:** Flush / drop valve not closing.

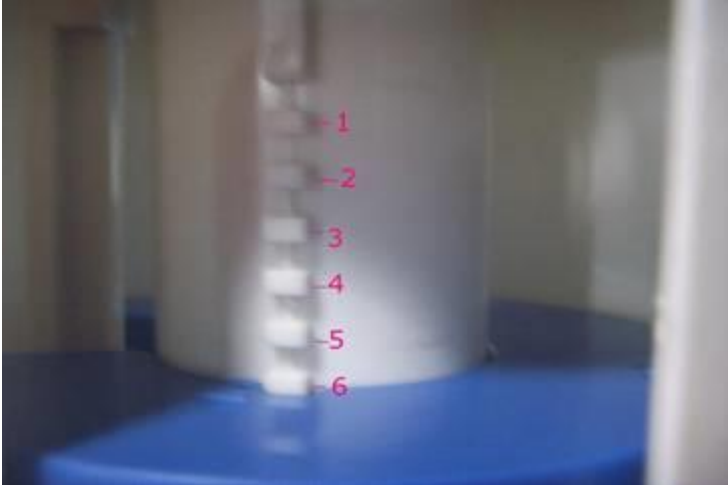
- The blue float controls the **small flush volume**. This should be pre-set '6 buckles' down. Moving it further down increases the small flush volume and up decreases the small flush volume.

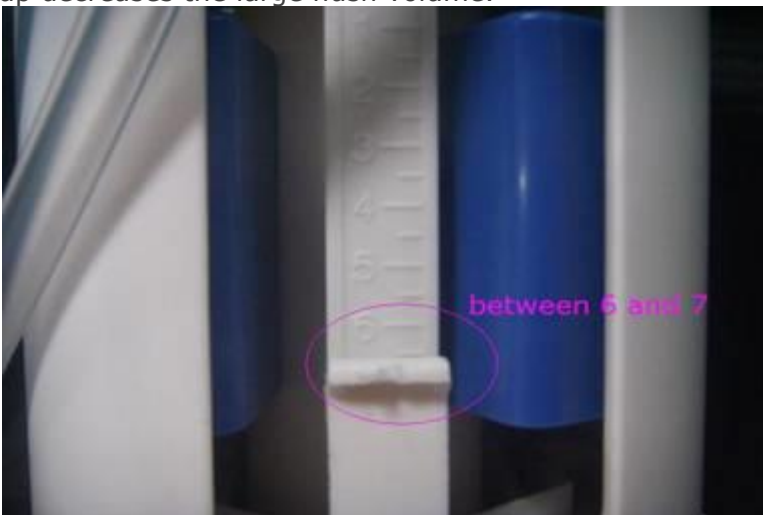
- The white plastic slider controls the **large flush volume**. This should be pre-set to between 6 & 7. Moving it further down increases the large flush volume and up decreases the large flush volume.
