Moselle Basin Mixer & Press Top Waste

MOS113

Installation Guide

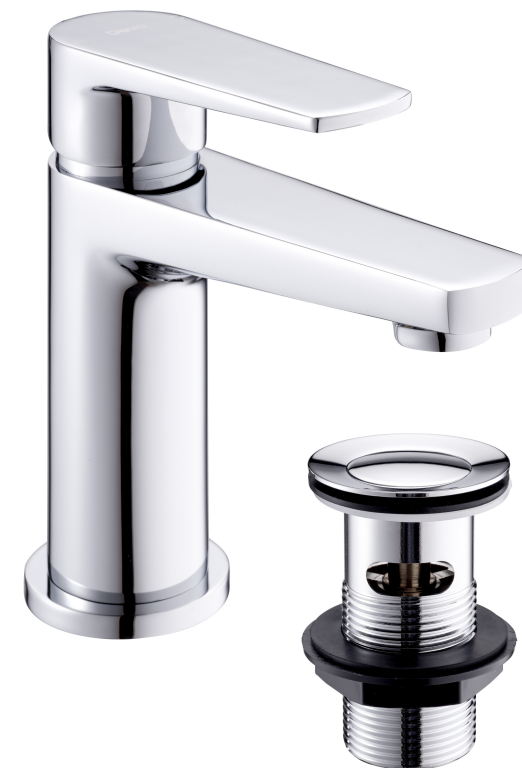
- Suitable for high & low pressure systems
- 35mm ceramic cartridge
- H & C temperature indicator
- Tilt and turn temperature and flow control
- Tap Height 149mm,
- Spout Height 97mm
- Spout Reach 110.5mm
- Supplied with fixing kit(metal horseshoe fixing plate, rubber horseshoe fixing washer, metal bar and locking nut)
- Supplied with 2 x M10-450mm flexi tails
- Complete with brass slotted press top waste
